Type-2 Ceiling Space Investigation for Presence of Plaster

Tabaret Hall Building, University of Ottawa Campus, Ottawa, Ontario

BCE Project: 22-824

Report Issued: October 28, 2022

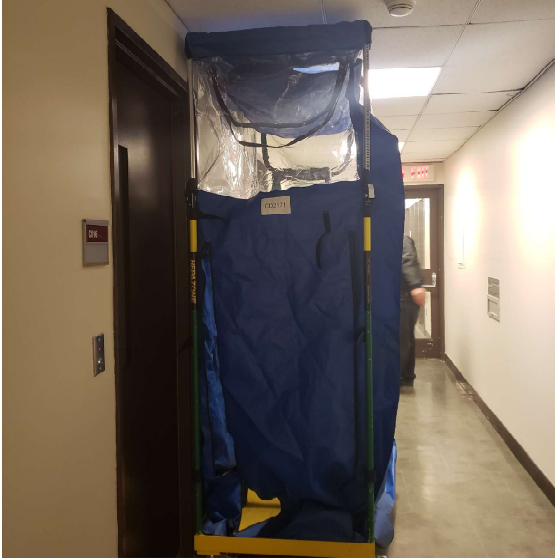
Photo #		Material Location / Description
1

View of Type 2 (intermediate/Moderate Risk) mobile containment used during the ceiling space investigation.
2

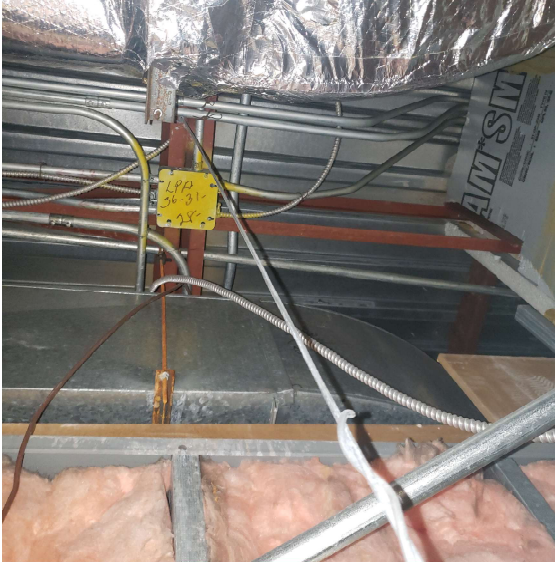
View of corrugated metal ceiling observed in room M083A-E and room C01D.

- W-Wing level 00 → Concrete slab
- Area around staircase C (C01B) → Concrete Slab
- Room M083A-E and Room C01D → Corrugated Metal
- Area L113 → Concrete Slab
- Area N101 → Concrete Slab
- L-Wing level 3 → Concrete Slab
- C-Wing level 4 (C450, C452, C455-C459) → Concrete Slab

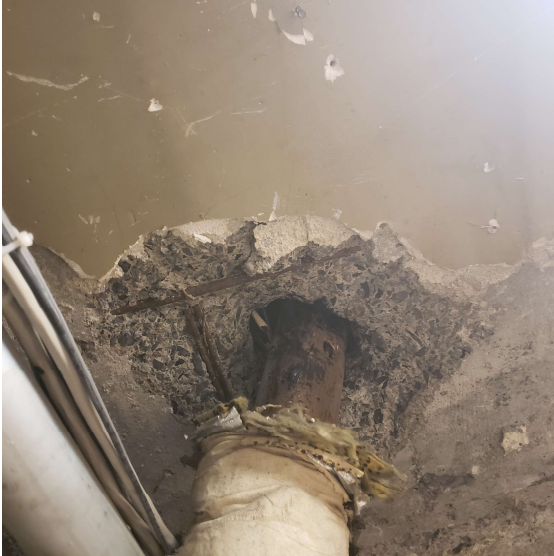
Photo #		Material Location / Description
3

A photograph showing a close-up view of a ceiling. The top part of the image shows a dark, textured surface, likely the acoustic ceiling tiles. Below this, there is a large, irregular hole in the ceiling, revealing a rough, greyish-brown plaster surface. A white pipe or duct is visible on the left side, and a yellowish-green material is visible at the bottom of the hole.	General view of plaster ceiling observed above acoustic ceiling tiles.
4

The remaining areas noted on drawings labelled as plaster ceilings were observed to have plaster ceilings above the dropped acoustic ceiling tile grid or plaster above solid drywall (observed through a hatch).

- Entry into ceiling spaces throughout the building where plaster was identified above dropped acoustic ceiling tile grid will require Type-2 asbestos abatement precautions due to the presumed presence of asbestos-containing plaster debris.
 - Please refer to **Appendix B** for locations of asbestos-containing plaster;
- This report should be provided along with the full building DSR and project specific DSR to contractors prior to conducting demolition or renovation work at the Site. Further, contractors shall have an exposure control plan in place for each designated substance identified in this report.
- This report should be used to supplement the full building DSR as there are many other asbestos-containing materials within the building that could impact work being completed in ceiling spaces (asbestos-containing ceiling tiles, asbestos-containing drywall joint compound, etc.)

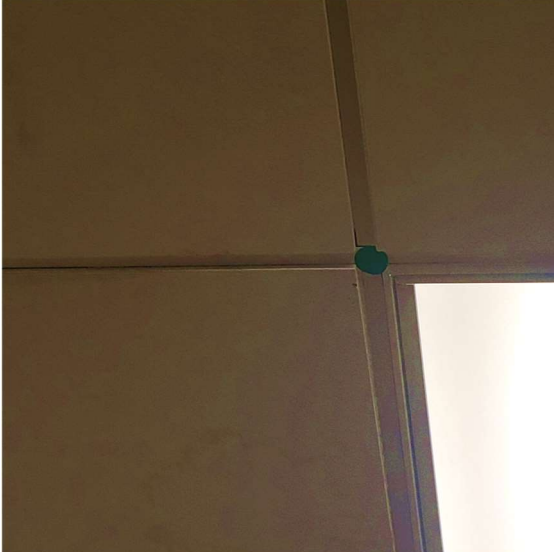
A photograph showing a close-up view of a ceiling. The image shows a dark, textured surface, likely the acoustic ceiling tiles. A green sticker is placed on the frame of the tiles, indicating that plaster is not present on the ceiling above the tiles.	View of green sticker placed on the acoustic ceiling tile frame indicating plaster is not present on the ceiling above the tiles.
