# Ceiling Space Investigation for Asbestos-Containing Materials

Fauteux Hall Building, University of Ottawa Campus, Ottawa, Ontario

BCE Project: 23-366

Report Issued: August 22, 2023

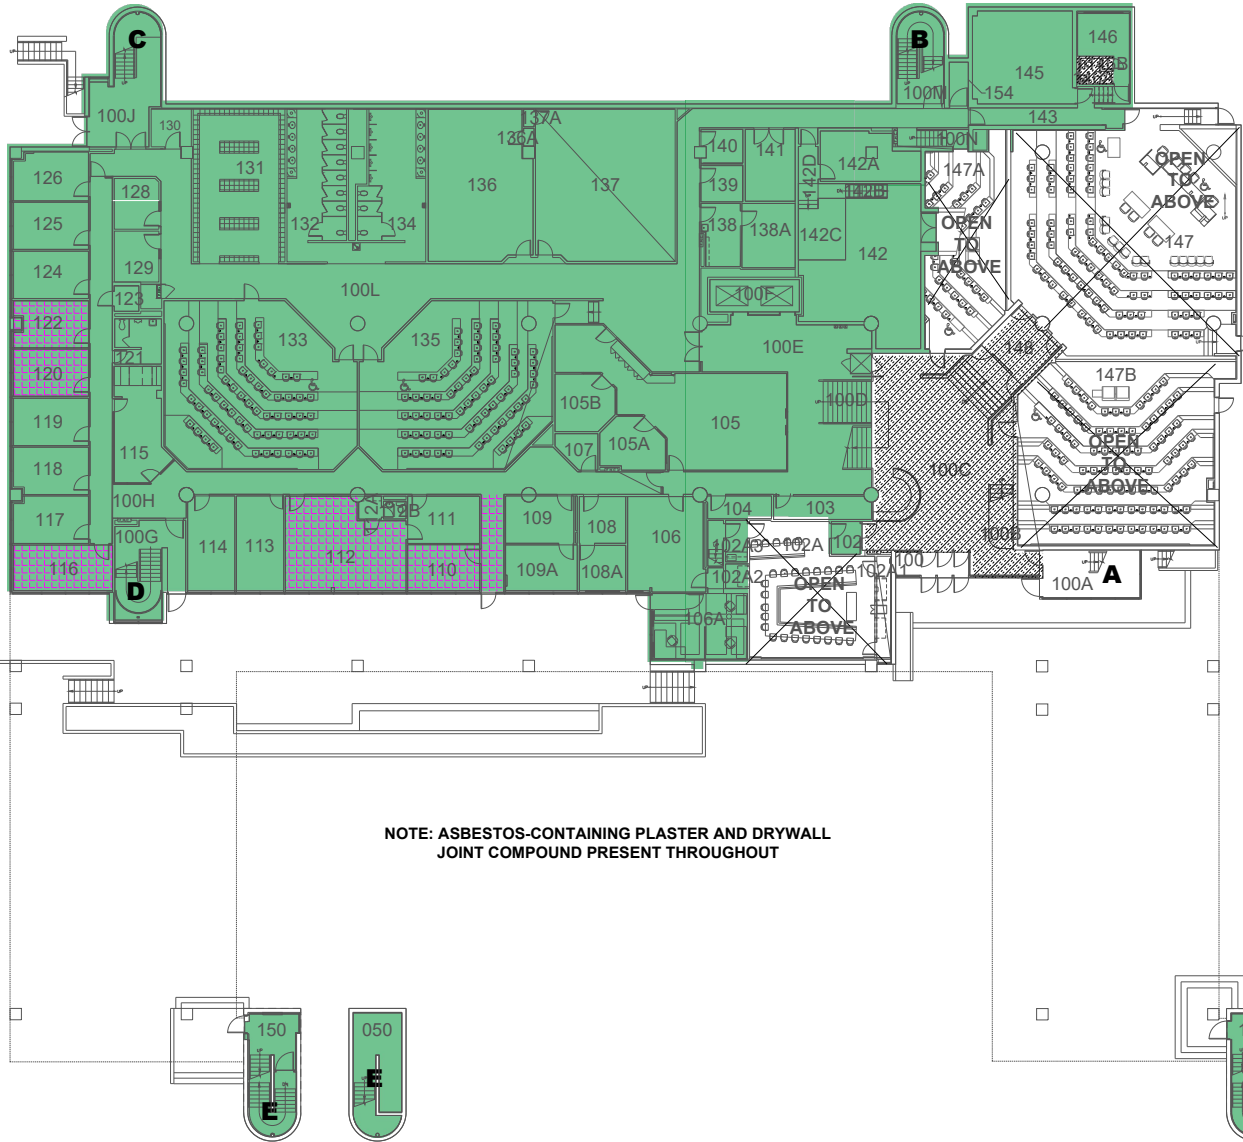
1 LEVEL 1 FLOOR PLAN, FAUTEUX HALL  
NTS

**NOTE: ASBESTOS-CONTAINING PLASTER AND DRYWALL  
JOINT COMPOUND PRESENT THROUGHOUT**

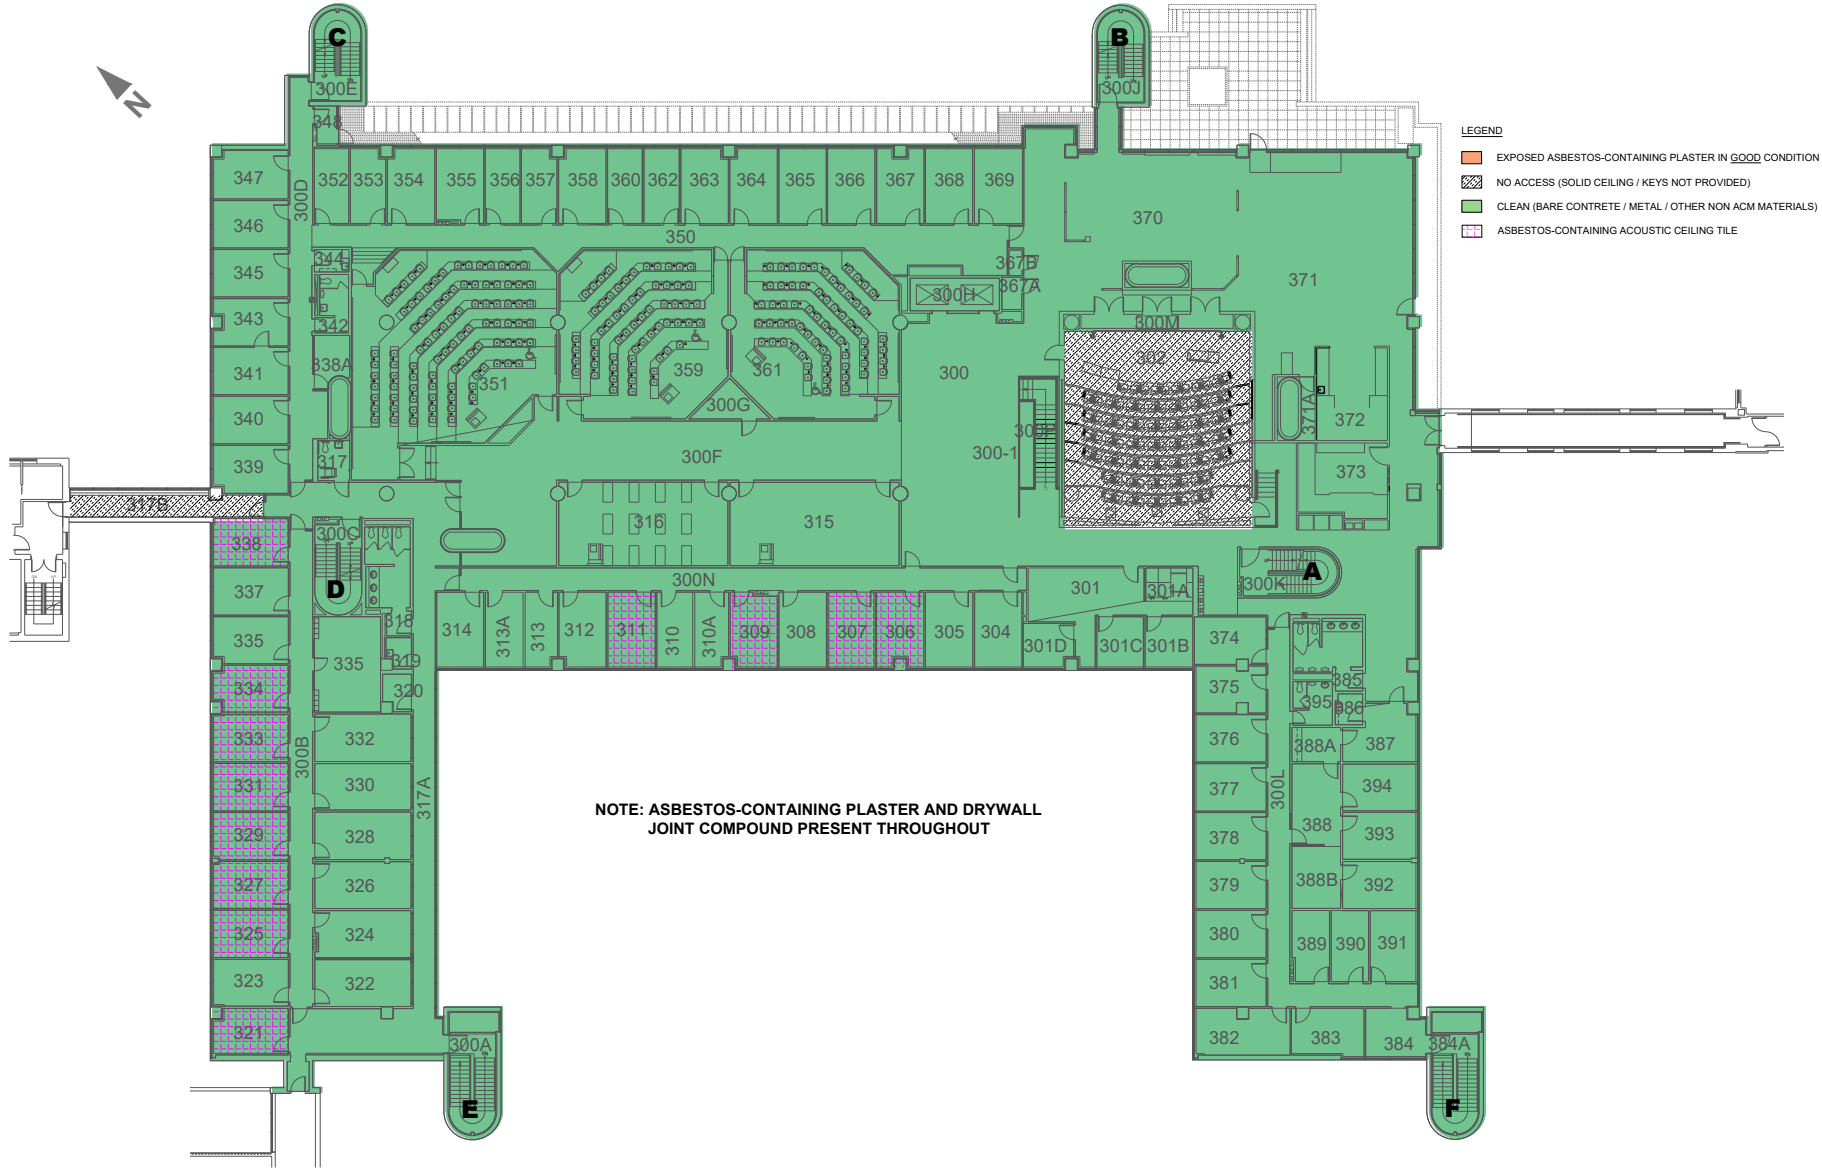
1 LEVEL 3 FLOOR PLAN, FAUTEUX HALL  
NTS

**NOTE: ASBESTOS-CONTAINING PLASTER AND DRYWALL JOINT COMPOUND PRESENT THROUGHOUT**

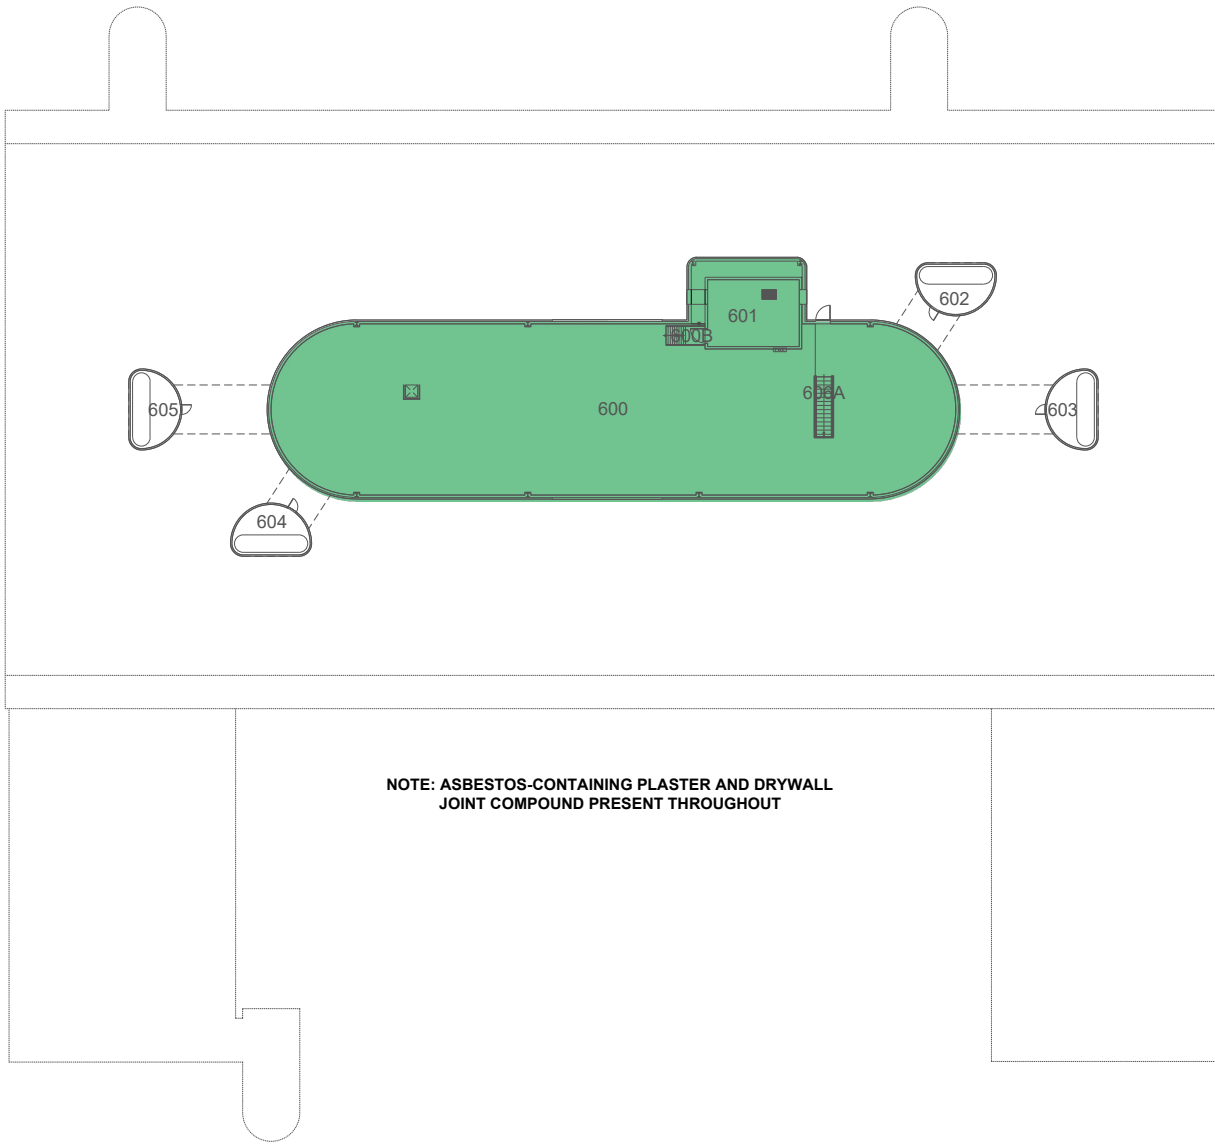
NOTE: ASBESTOS-CONTAINING PLASTER AND DRYWALL JOINT COMPOUND PRESENT THROUGHOUT
