HAZARDOUS MATERIALS SURVEY AND 2022 REASSESSMENT 538-540 KING EDWARD AVENUE, OTTAWA, ON

Project No.: Z2021101HZ / CCC-230252-00

University of Ottawa

McIntosh Perry Limited (MPL)

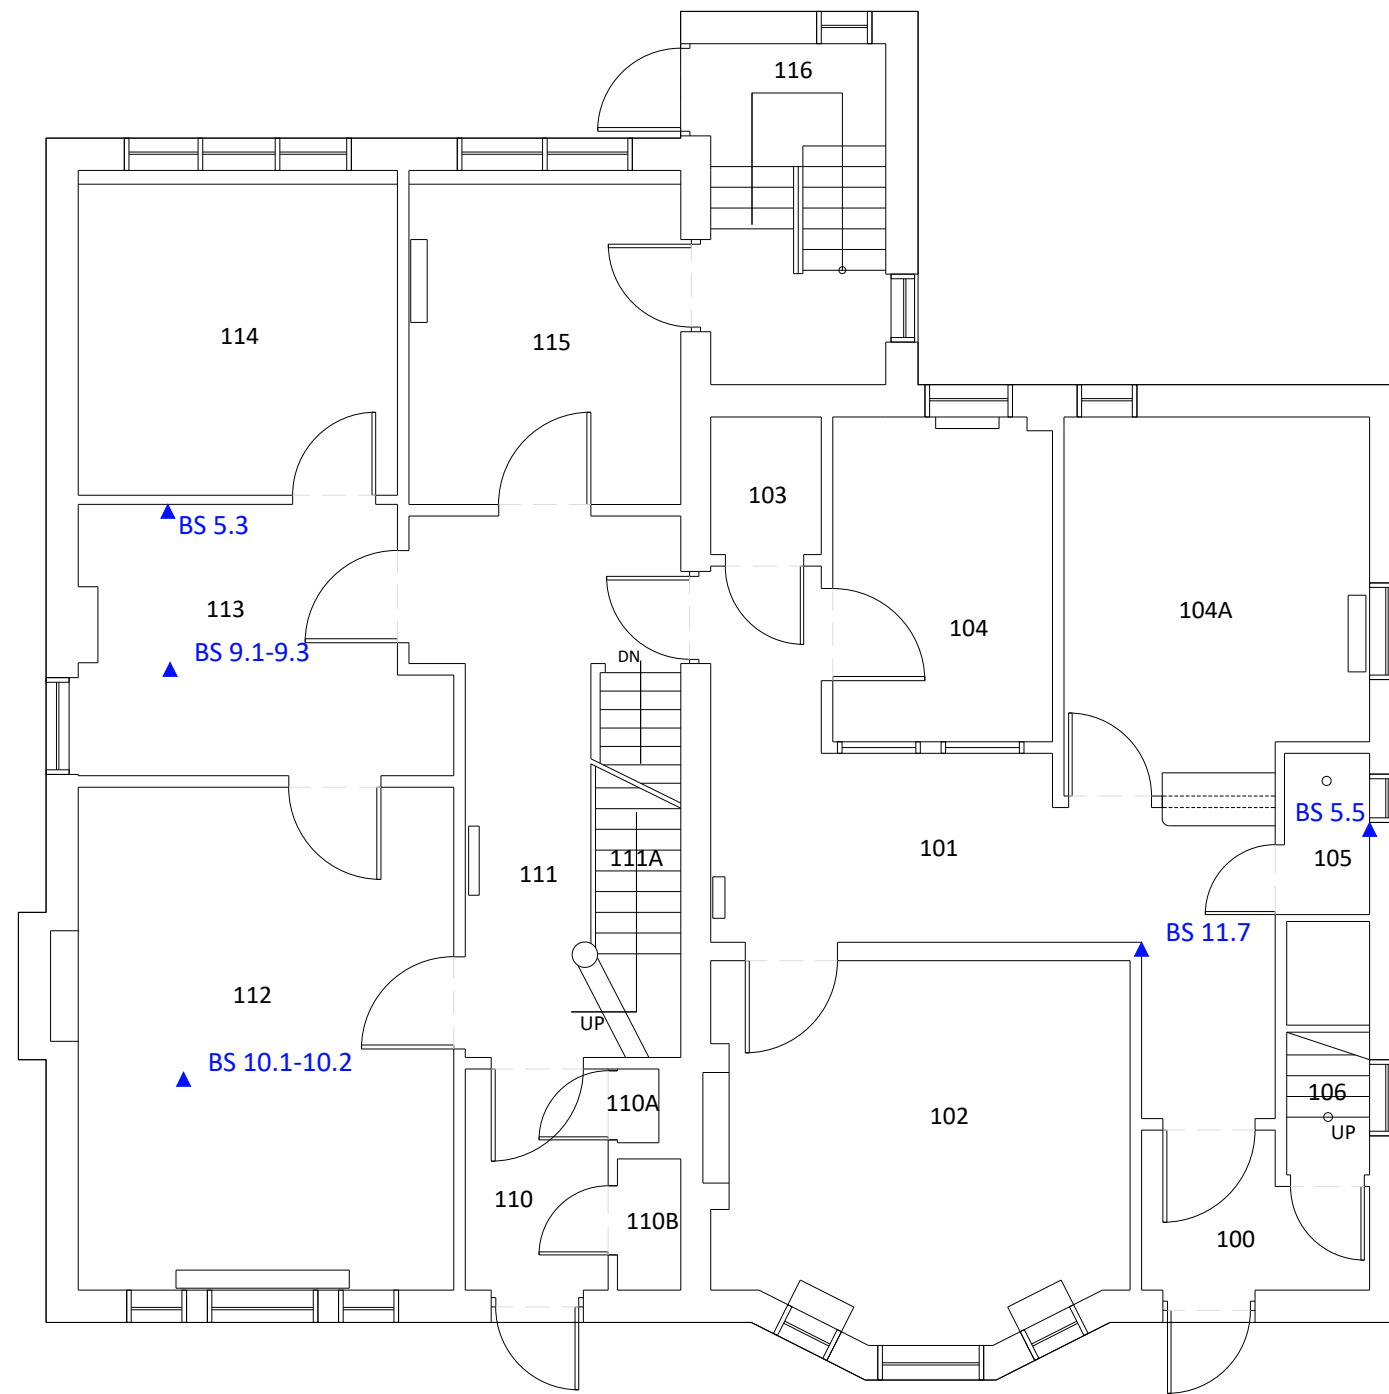
<p>McINTOSH PERRY 6240 HIGHWAY 7 SUITE 200 WOODBRIDGE ON L4H 4G3 Tel: 905.856.5200 Fax: 905.695.0221 Toll Free: 1.888.348.8991 www.mcintoshperry.com</p> <p>Legend: ▲ Asbestos Bulk Sample □ Lead Paint Sample <LOD ■ Lead Paint Sample >LOD</p> <p>Note: ACM plaster and drywall with ACM joint compound is present throughout</p> <p><small>THE CONTRACTOR SHALL CHECK AND VERIFY ALL DIMENSIONS, REPORT ALL ERRORS AND OMISSIONS TO THE CONSULTANTS, PRIOR TO PROCEEDING WITH ANY WORKS.</small></p>	<p>CLIENT: UNIVERSITY OF OTTAWA</p> <p>PROJECT: HAZARDOUS MATERIALS SURVEY 538-540 KING EDWARD, OTTAWA, ON</p>	<p>TITLE: MASTER DRAWING LEVEL 01 SAMPLE LOCATION</p> <p>SCALE: 1:100</p> <p>DRAWN: D.B.</p>	<p>DATE: JUNE 15, 2020</p> <p>CHECKED: M.M.</p>	<table border="1" style="width: 100%; border-collapse: collapse;"> <tr> <th>REV. NO.</th> <th>DESCRIPTION</th> <th>DATE</th> <th>BY</th> <th>APPD.</th> </tr> <tr> <td> </td> <td> </td> <td> </td> <td> </td> <td> </td> </tr> </table>	REV. NO.	DESCRIPTION	DATE	BY	APPD.						<p>DRAWING NUMBER: A-01</p>
